JANUARY 2022

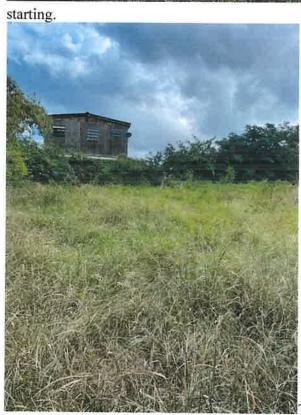
The surrounding properties has not changed.

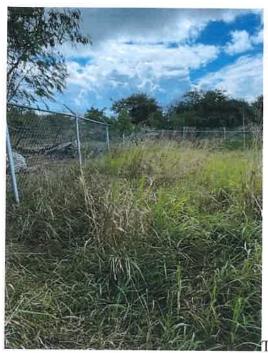
The parcel is no finished.

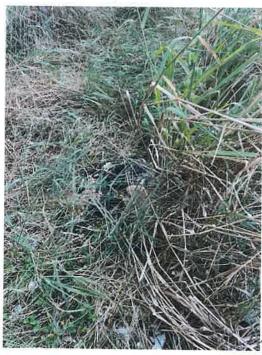
There is still some debris visible through the grass.
