**ENVIRONMENTAL ASSESSMENT REPORT  
REQUEST FOR A ZONING VARIANCE FOR  
PARCELS 4I AND 4J REM  
ESTATE ST. JOSEPH AND ROSENDAHL  
ST. THOMAS, U.S. VIRGIN ISLANDS**

**PREPARED ON BEHALF OF  
A.C. DEVELOPMENT  
ST. THOMAS, U.S. VIRGIN ISLANDS**

**PREPARED BY  
BIOIMPACT, INC.**

**DECEMBER 2024**

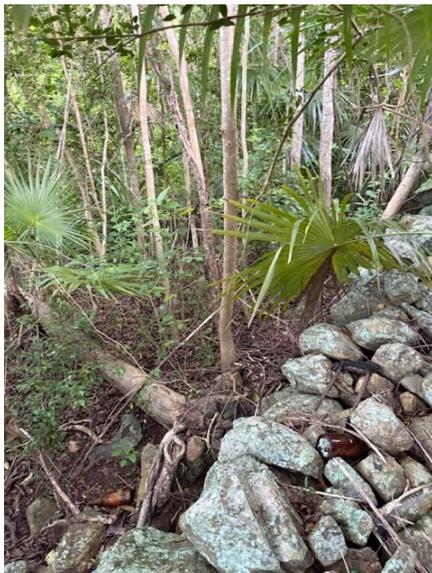
There is an old stone wall (common in St. Thomas) and scattered older refuse within the property.

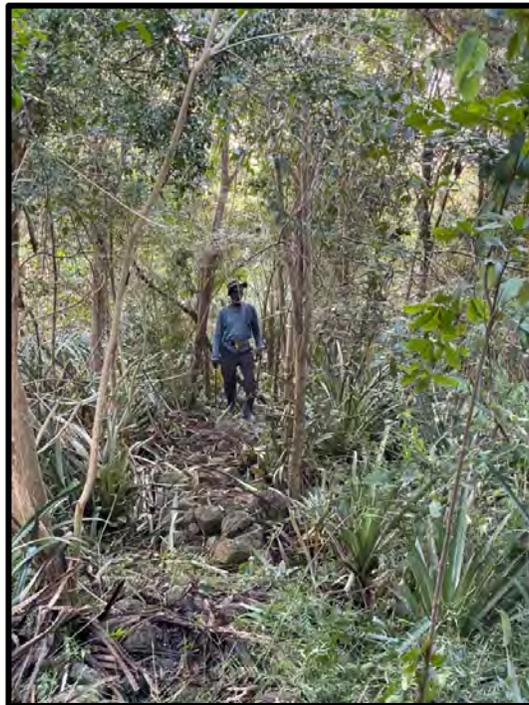
Figure 15: Photograph of the dry laid rubble wall, view to the northwest, where significant parts of the wall alignment have collapsed or been robbed.

The archeological survey resulted in the identification of a dry laid, rubble wall on Plot 4J Rem. This wall has segments that are well preserved, as well as collapsed sections. The rock from the short section of the wall that turns to the south appears to have been robbed of significant parts of the stone. Because of the right angle turn of the wall, it appears as if this was an enclosure for cattle
