**MAJOR LAND AND WATER
SUPPLEMENTAL ENVIRONMENTAL ASSESSMENT
IN RESPONSE TO QUESTIONS FROM PUBLIC AND CZM
FOR THE
LATITUDE 18 VESSUP BAY MARINA
ST. THOMAS, U.S. VIRGIN ISLANDS**

APPLIED TECHNOLOGY & MANAGEMENT, INC
BIOIMPACT, INC.
DESIGN DISTRICT ARCHITECTS
HARRIS CIVIL ENGINEERS, LLC
JAREDIAN DESIGN GROUP
VESSUP OPERATIONS, LLC

DECEMBER 2022

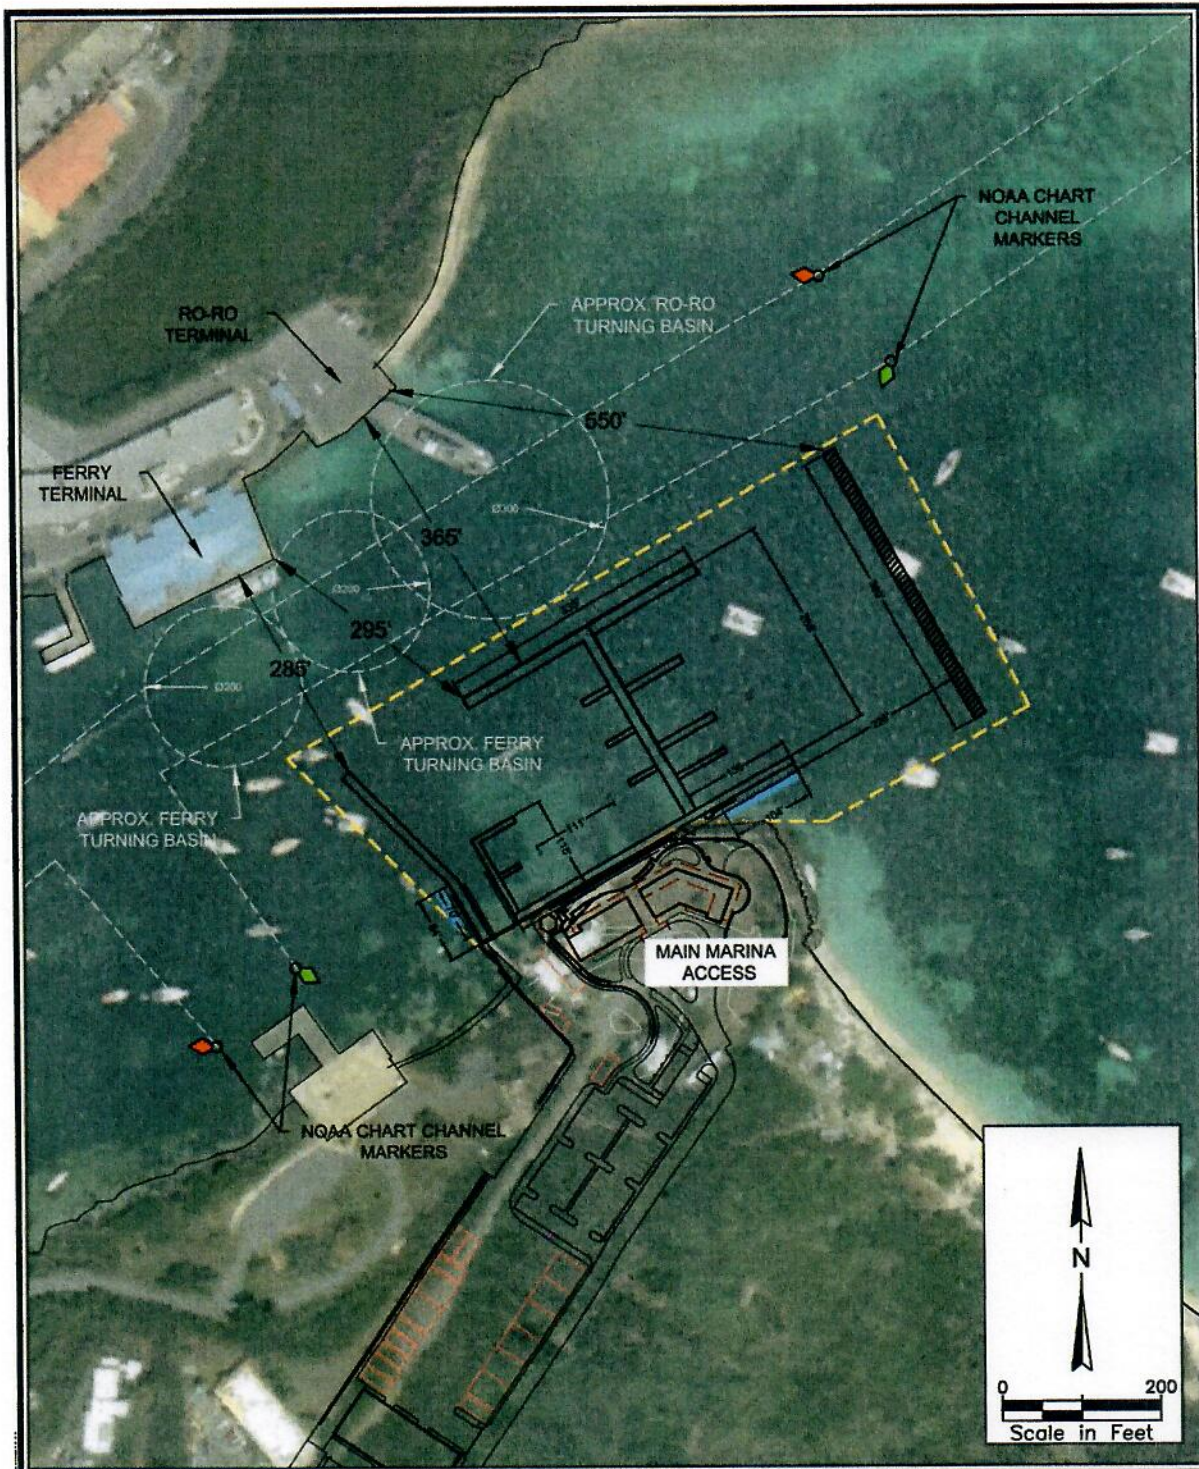
Figure 5.01 Navigational Areas

The mooring field area will be identified with new markers and additional navigation aids will be installed to better identify the navigation channels. The Port Authority was consulted to validate the navigation channel and location of navigation aids. The following figure shows the docks in relationship to the ferry terminal and ferry navigation areas.

<p>ATM A Chesapeake Company 2047 Vista Parkway, Suite 201 West Palm Beach, FL 33411 (561) 659-0041 Certificate of Authorization #4669</p>	<p>OVERALL PROPOSED PLAN MARINA</p> <hr/> <p>Vessup Point Marina</p>	<p>Requested by: Jack Rock B-A, LLC Redhook Hayes B Rem, LLC</p> <hr/> <p>Sheet Number: 8 of 24</p> <hr/> <p>FOR PERMITTING PURPOSES ONLY NOT FOR CONSTRUCTION</p>	<p>Location: Vessup Bay, St. Thomas, USVI Parcel ID: Waterbody: Muller Bay - Vessup Bay</p> <hr/> <p>Latitude: 18 19' 32" N Longitude: 64 50' 54" W</p> <hr/> <p>Issue Date: xx-xx-xxxx</p>
---	--	--	---

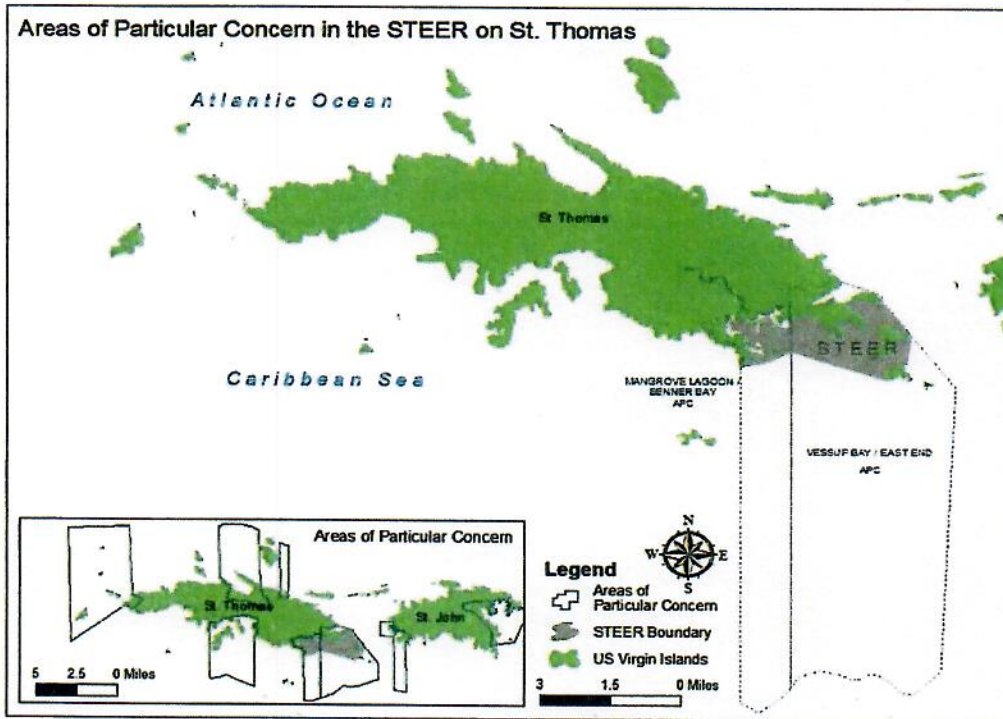
Figure 5.01.1 Areas of Particular Concern (STEER (2011) St. Thomas East End Reserve Management Plan. St. Thomas, USVI.

The subject parcels are within the Vessup Bay/ East End Red Hook Area of Particular Concern (APC) (Figure 5.01.1). The Vessup Bay/Red Hook APC is located on the eastern end of St. Thomas and includes Nazareth, Muller, Vessup, Red Hook, Great Bay, Cowpet Bay, Cabrita, Beck and Water Point, Great St. James, Little St, James, and Dog Island.

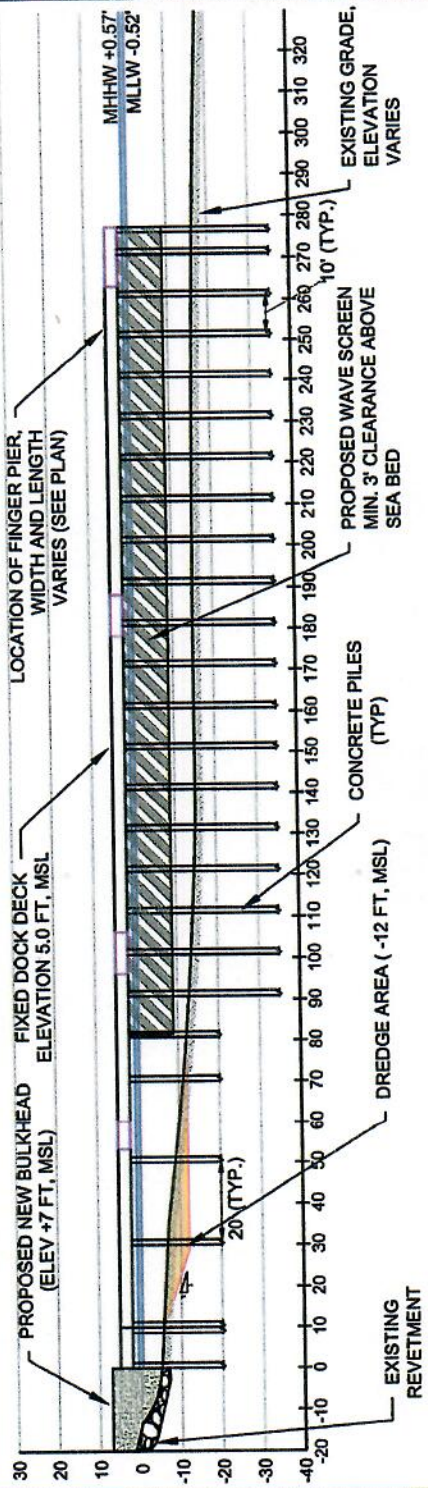
FIXED DOCK A-2
SECTION A-A' 1"=40'

A wave screen attached to Dock A-2 is proposed in areas shown on the Drawings to attenuate locally generated waves and wakes and improve user comfort under normal operational conditions. The location and size of the wave screen was modeled to demonstrate that it will not adversely impact flushing of Vessup Bay.

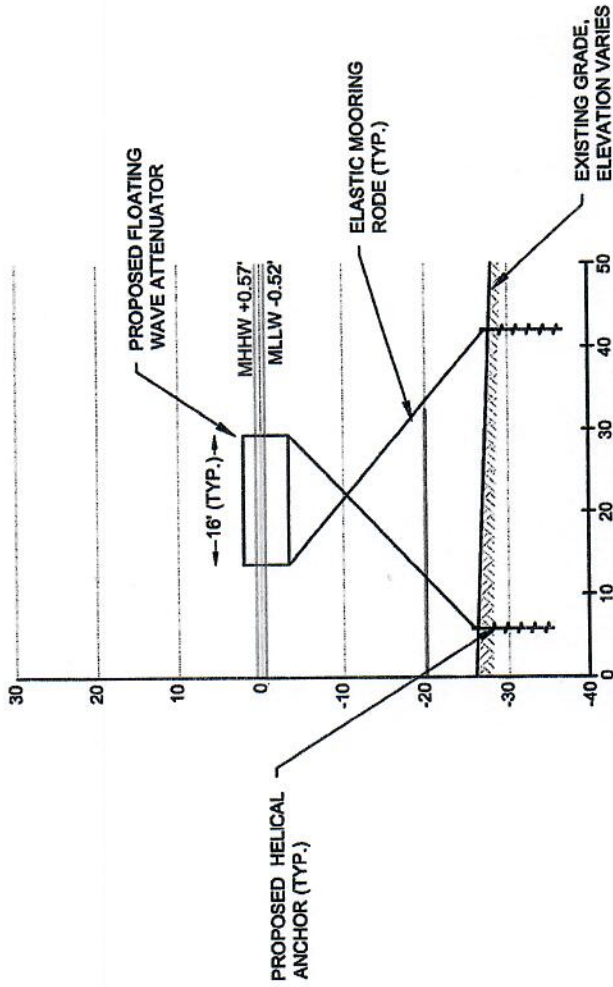
WAVE ATTENUATOR
SECTION H-H' 1"=20'

The marina includes wave attenuation devices to provide comfort during operational conditions. A wave screen attached to the main fixed pier is proposed in areas that do not impede circulation flows. A floating wave attenuator is proposed to protect the marina slips facing Muller Bay and to reduce the need for wave screens.

As shown on Proposed Wave Attenuator drawing and the Section H Wave Attenuator drawings the floating breakwater would be installed with either helix anchors. As shown in the benthic habitat map Figure 6.06.8 Benthic Habitat in the Marina Area, the wave attenuator is in an area of Macro-algae and varying degrees *H. stipulacea*. The attenuator is anchored with helix anchors will have a negligible impact during installation, if blocks are placed it will have at most 700ft (0.016 acre) of algal/*H. stipulacea* impact (footprint and turbulence impact). The lines used will be elastic mooring rodes and will have no impact on the seafloor.

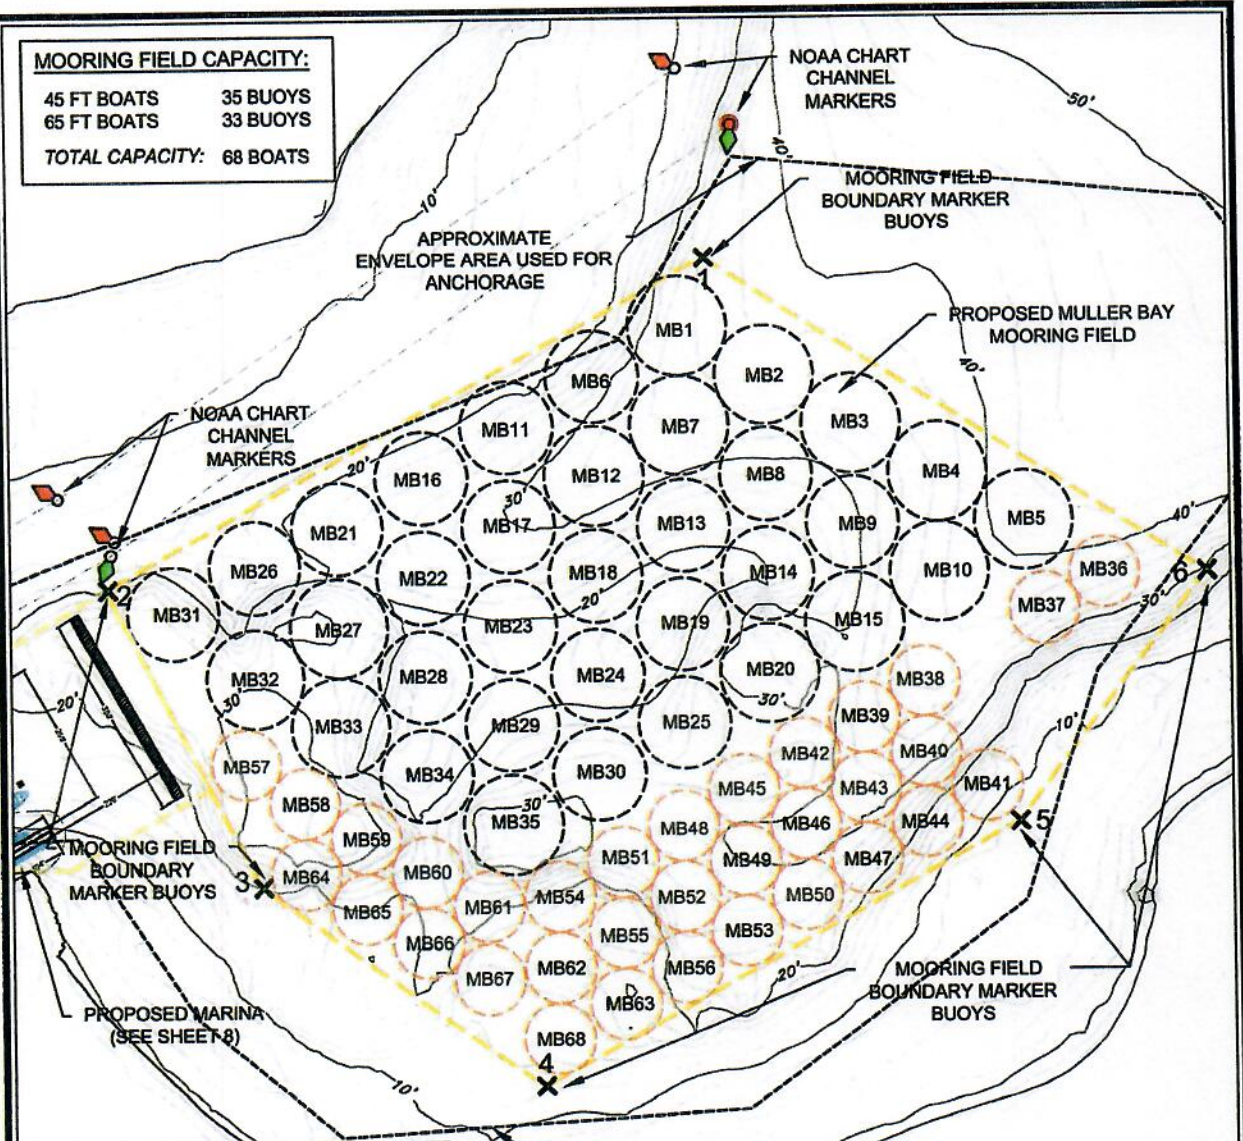
MOORING FIELD LIMITS

The mooring field includes 70 mooring buoys in Muller Bay, over 96 LF of berthing on two floating docks for dinghies, and upland support facilities such as showers, restrooms, and solid waste collection bins. Vessels in the mooring field will have access to the pump out at the fuel dock and will be prohibited by their mooring lease contract to discharge sewage or other pollutants.

MOORING FIELD CAPACITY:

45 FT BOATS	35 BUOYS
65 FT BOATS	33 BUOYS
TOTAL CAPACITY: 68 BOATS

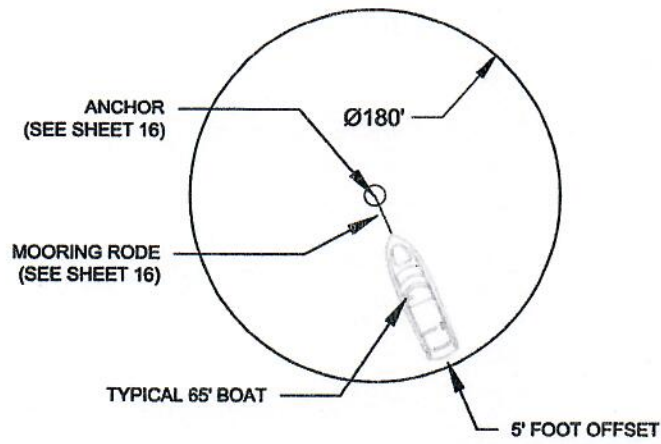
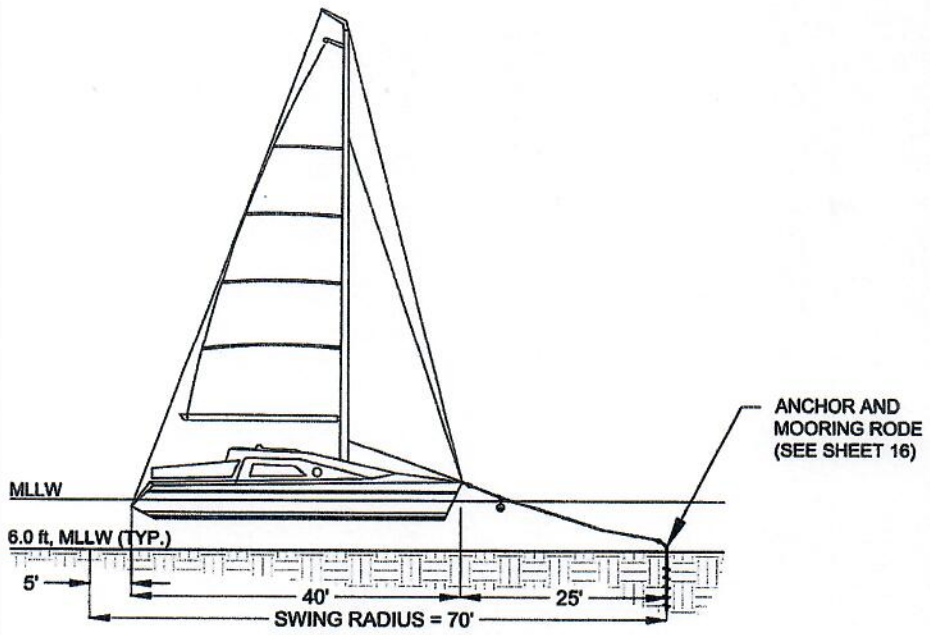
**TYPICAL VESSEL AT MOORING FIELD
VESSUP BAY 1"=20'**

**TYPICAL MOORING FIELD STATION
MULLER BAY (MB1 THRU MB68)**

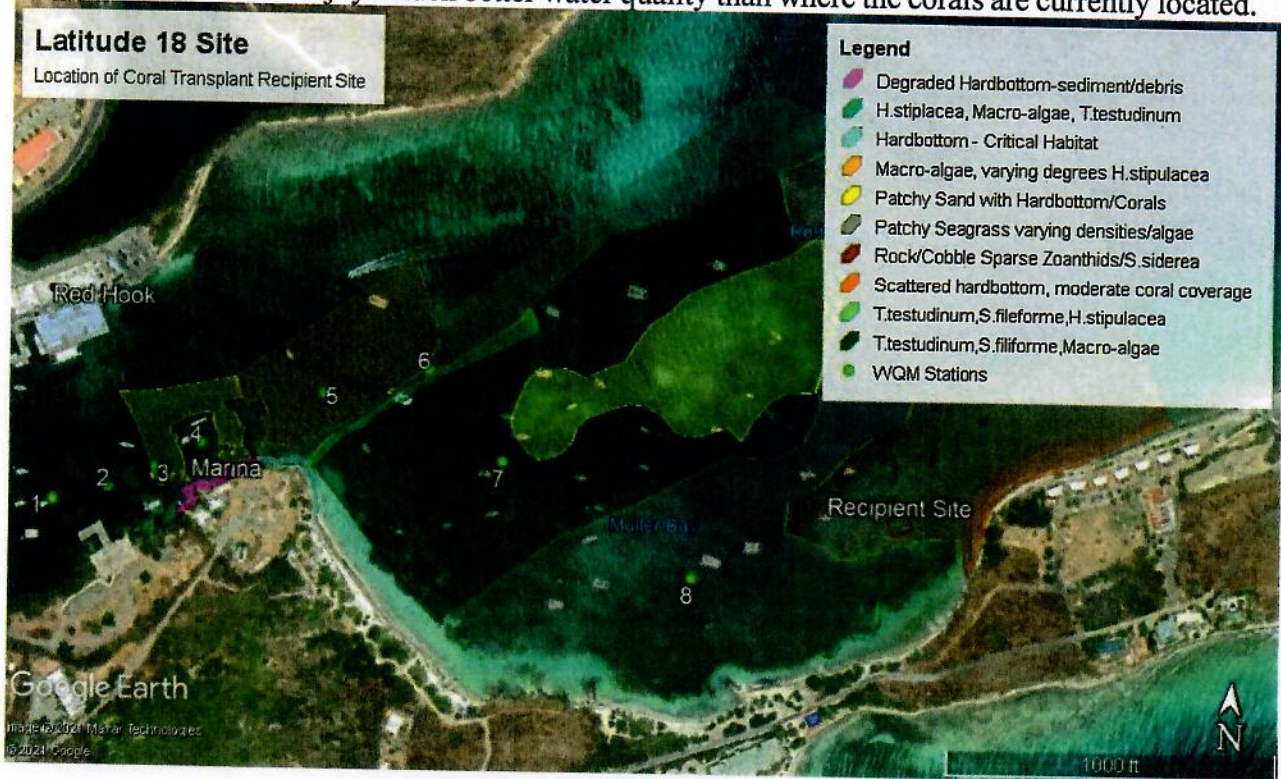
Figure 1. Location of transplant recipient site.

The intent is to transplant the 12 corals within the marina footprint to east to the large area of hardbottom. The area enjoys much better water quality than where the corals are currently located.

The recipient site is south of the proposed managed mooring field and is an area of broken pavement which enjoys excellent water quality. The corals will be planted at a similar depth from that they were taken from. The area has scattered *Pseudodiploria* and *Siderastrea*.

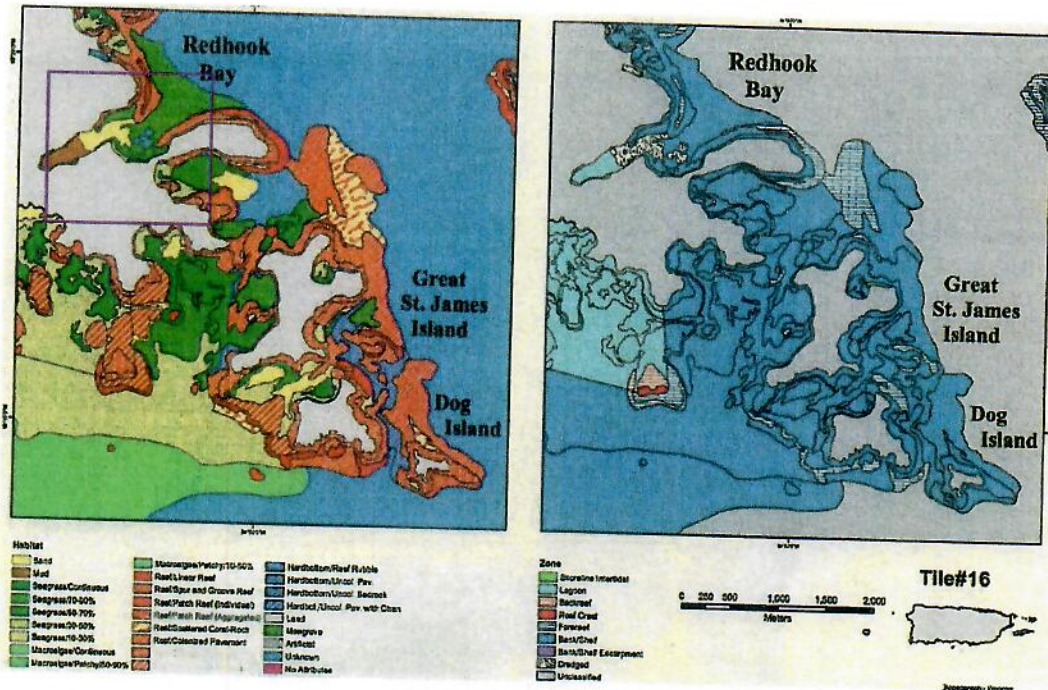
The NOAA NOS Benthic habitat map, depicts. This is an accurate description of the benthic habitats within the area. The NOAA NOS map is provided below followed by a benthic habitat map. Inner Vessup Bay is shown as mud with small areas of seagrass along the sides of the bay. The inner harbor is heavily algal colonized, and there is sparse seagrass along the edges. The area immediately off the marina site is shown as sand. This area is colonized by scattered algae and *H. stipulacea*. The NOS map shows seagrass 70-90% offshore, this area is more in the order of 30-40% and this area is highly impacted by *H. stipulacea*, anchors, ropes, and debris. The NOS map shows seagrass continuous along the eastern shoreline, again the seagrass is closer to 50%. The map shows an area of dredging in the bay which shows in the historic aerials shown in Section 6.02.

Figure 6.06.1. NOS Benthic Habitat Map Tile 16. Great Bay is shown within the blue box, and the project site is indicated by the red star.

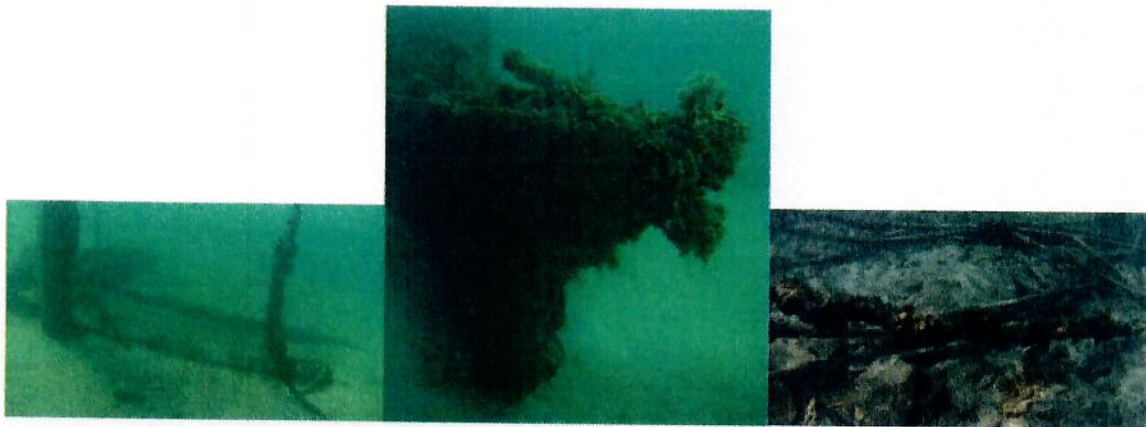
The seafloor is a mix of uncolonized sand, *Halophila stipulacea*, and scattered *Halimeda opuntia*, *Udotea flabellum* and *Penicillus capitatus*.

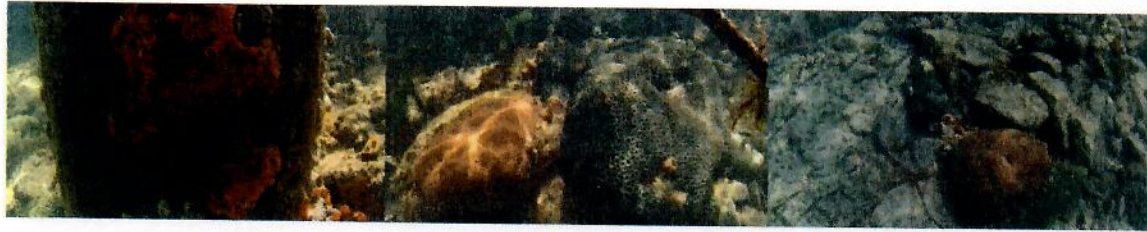
The sponges and corals represent less than 1% of the total bottom cover within the marina area.

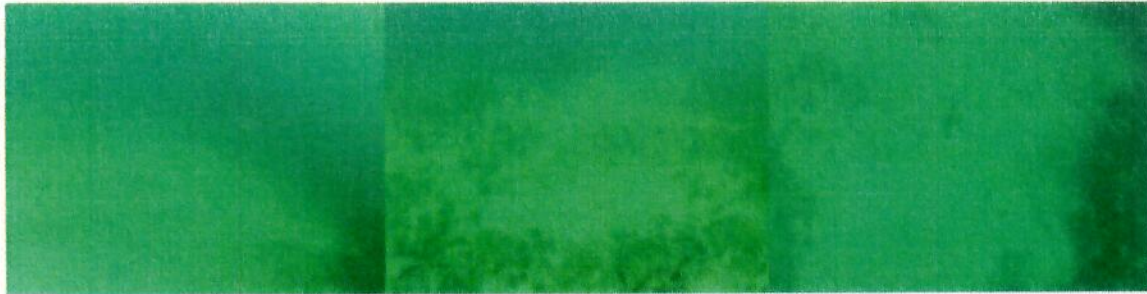
There are large scars that are the result of moorings. These are the result of mooring ropes dragging on the bottom. Some of the areas are recolonizing with algae and *H. stipulacea*.

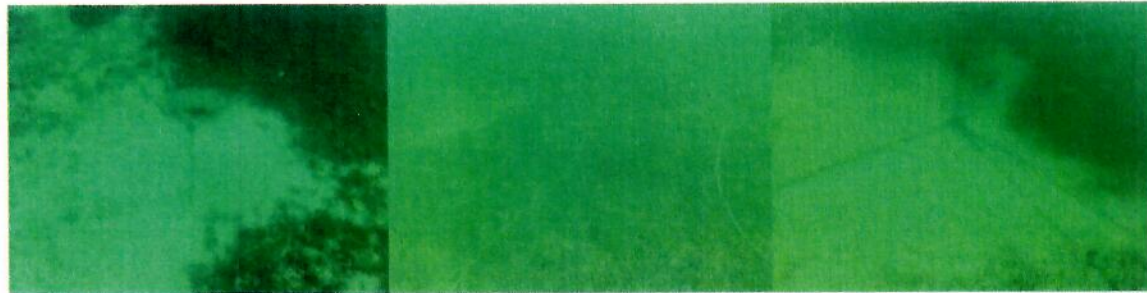
Some moorings use large rocks, other have three-point moorings which are resulting in large scour areas.

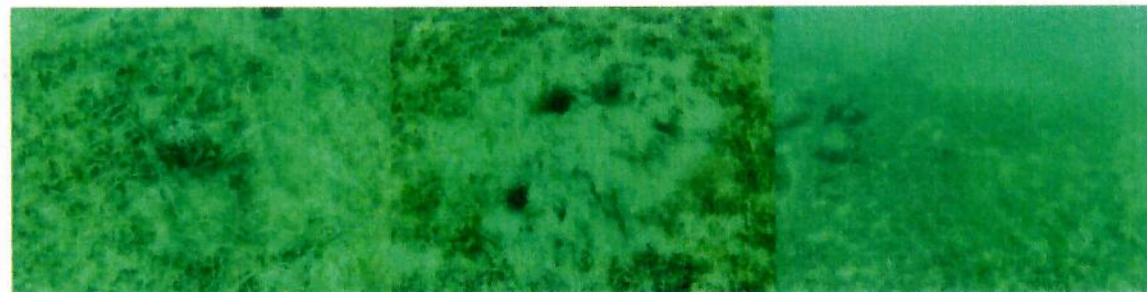
Moving to the east the area becomes intermixed with rocks and cobbles, slowly becoming a mix of emergent pavement with sand channels. At the edge of the pavement there loose rocks which have scattered corals. As shown in the photograph there are scattered helix anchors which are scattered where they have pulled out of the shallow sand.

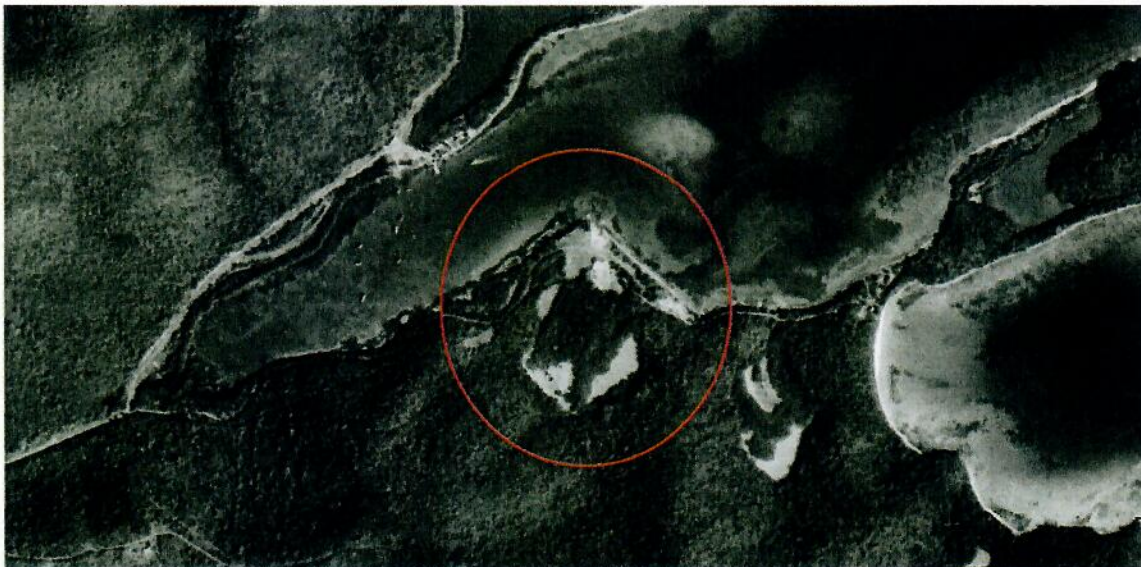
Prior to any development the area had an expansive wetland and salt pond and there was a rocky promontory on the point which was once referred to as Jack Rock. The 1954 USGS aerial below shows the site prior to the filling of the wetland.

The 1954 aerial shows expansive wetlands at the site, at the Ritz Carlton site and a pond which covers the width of Cabrita Point.

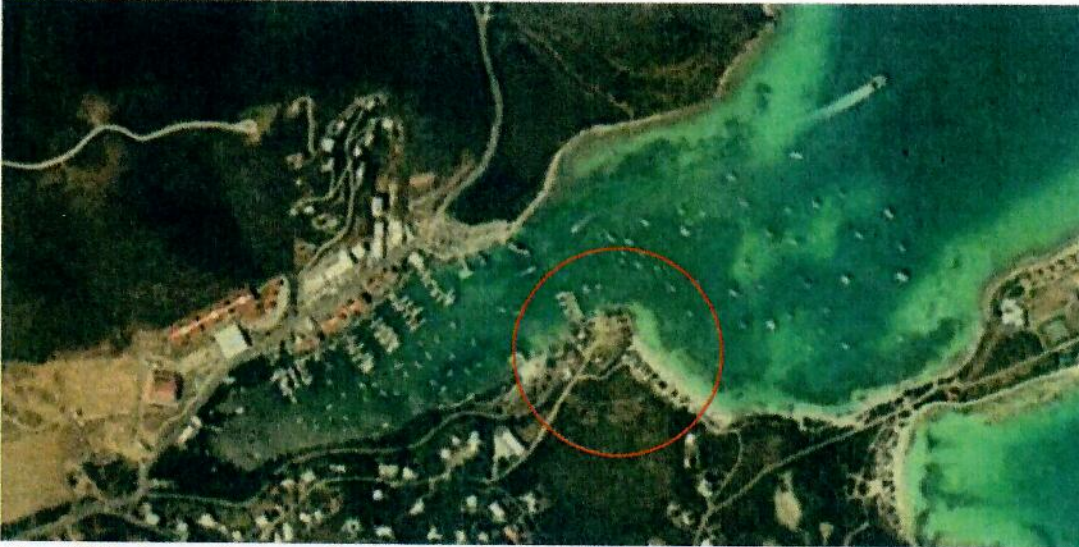
This 1999 shows that one dock was rebuilt, and the remnants of the more easterly dock are present. The easterly dock was destroyed by hurricane Marilyn.

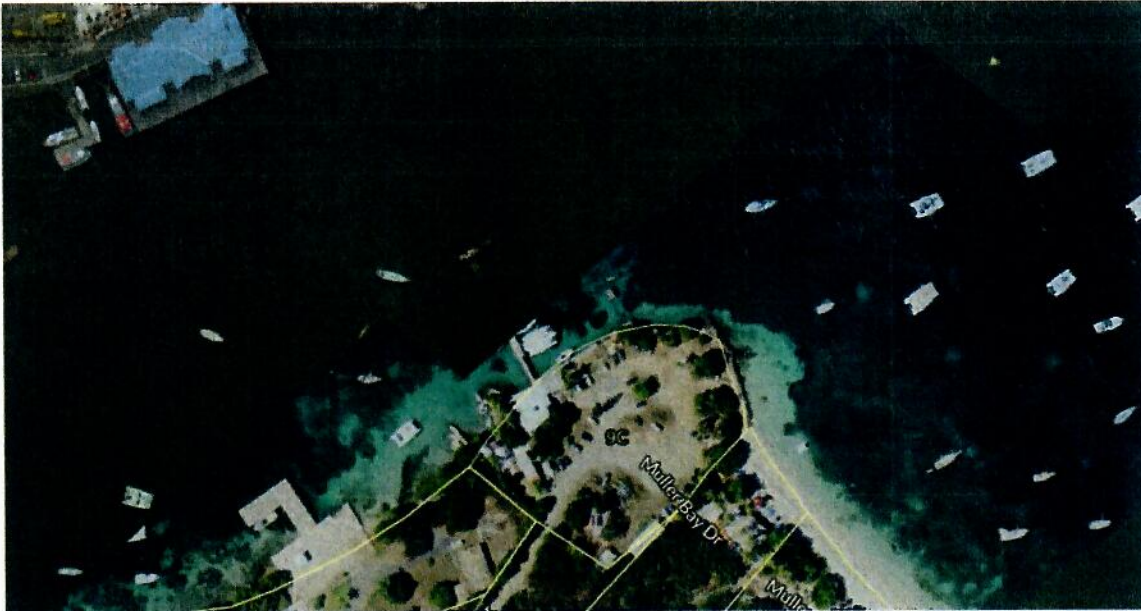
While this post Irma photograph on September 22nd did not cover the entire site it shows that the end of the dock was taken out by the second storm.

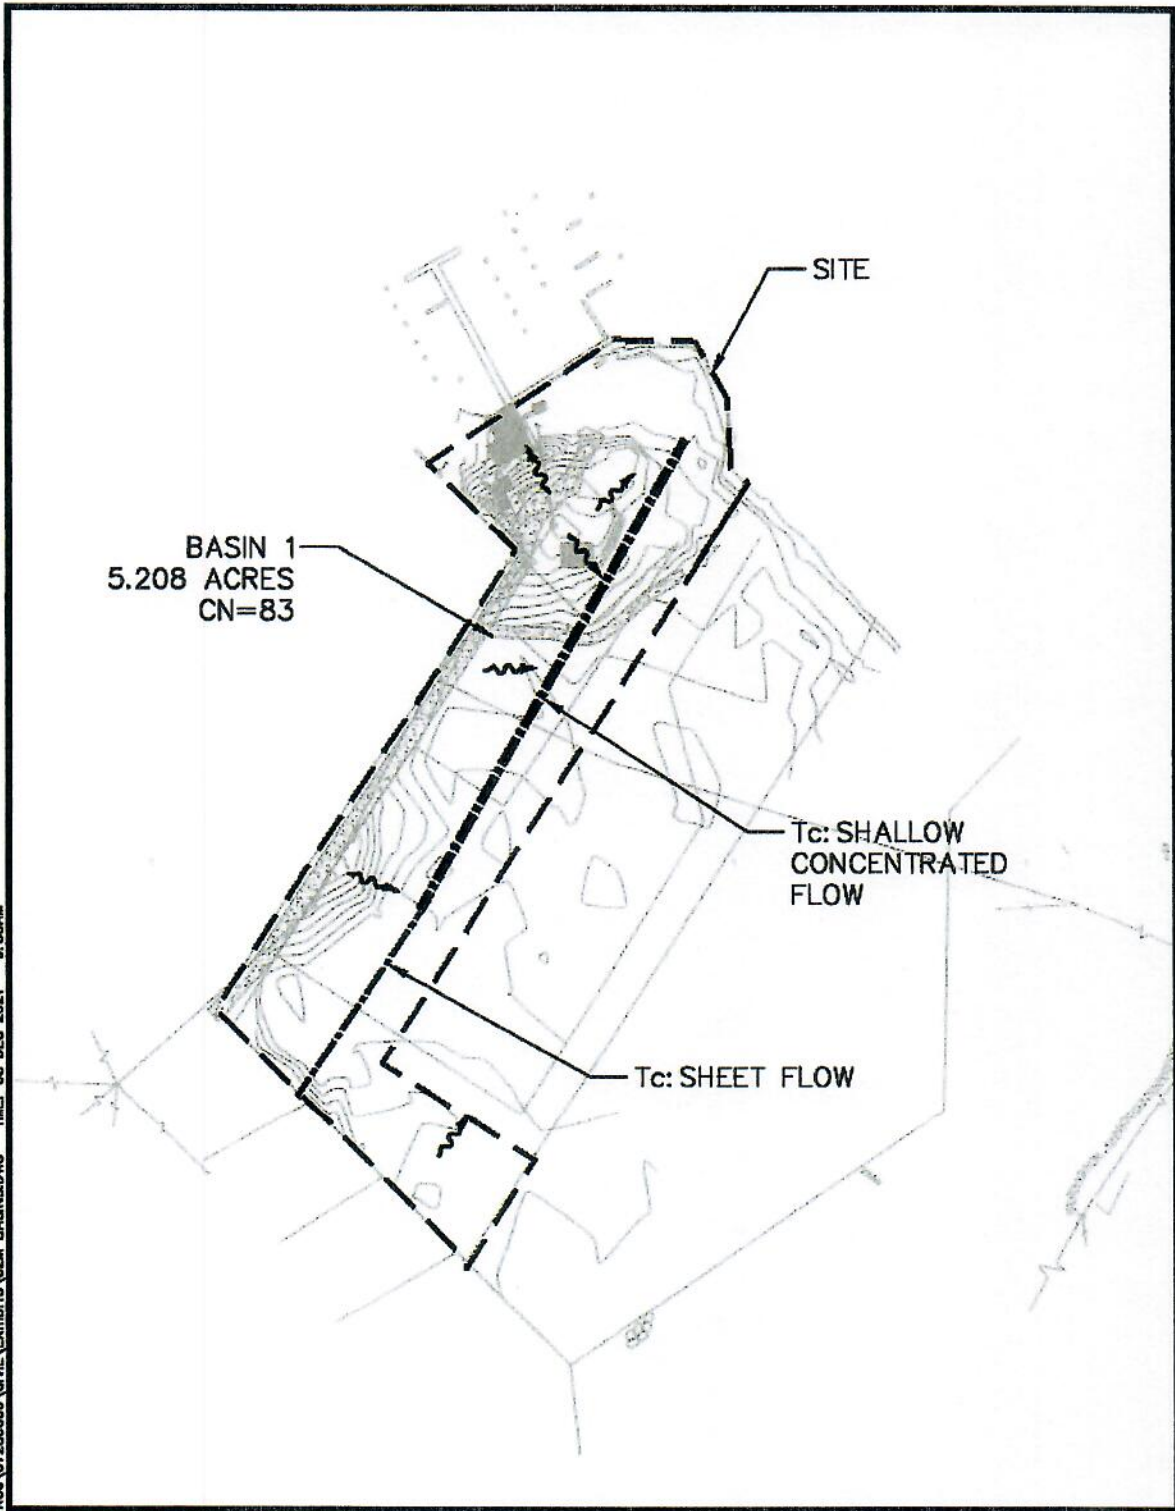
SECTION 5
FIGURE 1

LATITUDE 18
WATER RESOURCES MAP - EXISTING BASINS
 REFERENCE: SECTION 5.01.h

For any rainfall event, runoff generated on-site will be collected by stormwater inlets strategically located throughout the site. These inlets will initially direct the runoff through secondary stormwater piping to the primary stormwater pond. Under normal rainfall conditions the pond will allow for the settling of sediments and for the uptake of nutrients. In rainfalls which exceed the capacity of the pond the pond will serve to slow the discharge rate of the runoff and will allow some settling of larger particles and materials.

The pre and post development conditions have been modeled in AdICPR4 and shows that for each of the rainfall events run (2-year, 10-year, 25-year, and the 100-year), the post development discharge is lower than the predevelopment. The design is improving the discharge conditions by including the on-site stormwater pond.

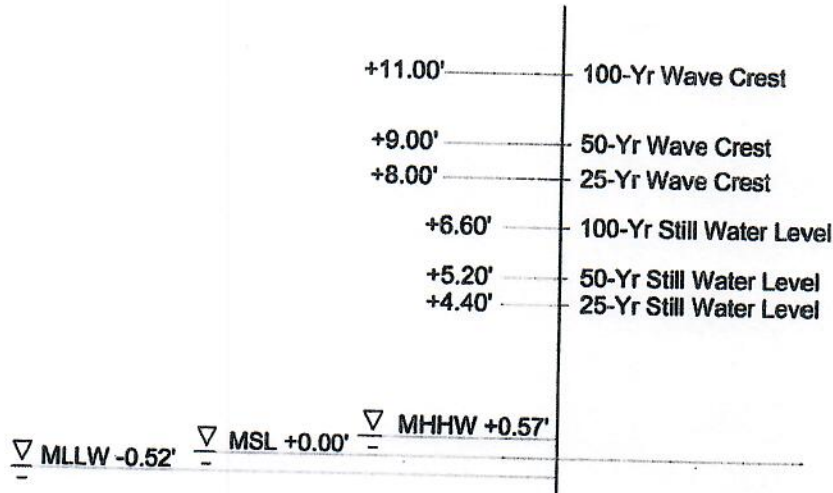
Figure 6.05.5: Summary Water Elevations. (*Wave crest values vary depending on project site's location.)

Based on the desktop review of tidal data, the wave studies and using the local mean sea level (MSL) as the vertical reference, the following still water levels and wave crest elevations are considered representative of conditions in the marina site:

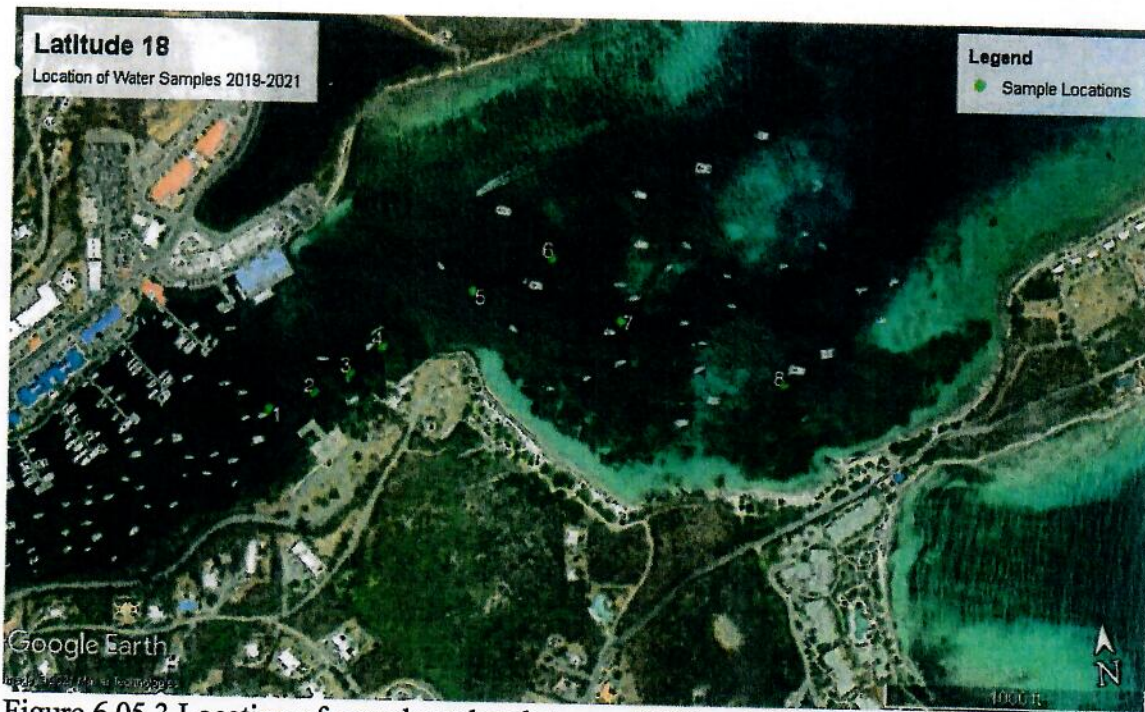
Figure 6.05.3 Location of samples taken between 2019 and 2021

Water sampling has occurred on the site over the last several of years in order to establish a baseline of water quality conditions. Samples were taken with a calibrated YSI EXO multi-meter and were taken at a depth of 1 meter. The samples from 2019 and the beginning of 2020 were focused within the marina. As the idea of a managed mooring field was considered additional sampling locations were added (Table 6.05.3). Samples were also taken during the current study which are provided in Table 6.05.4.F The map below shows the location of the samples.

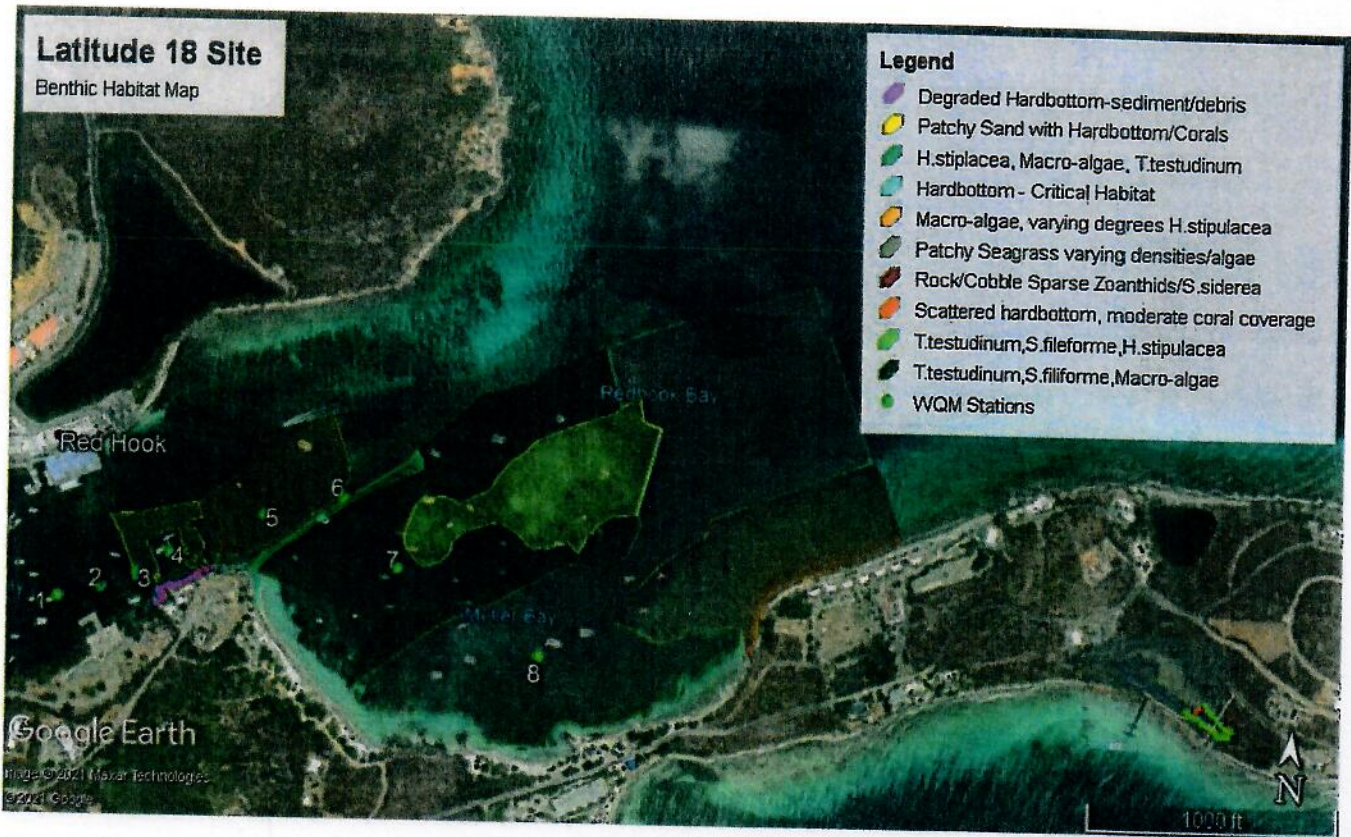
Figure 6.06.2 Benthic Habitat in the marina area

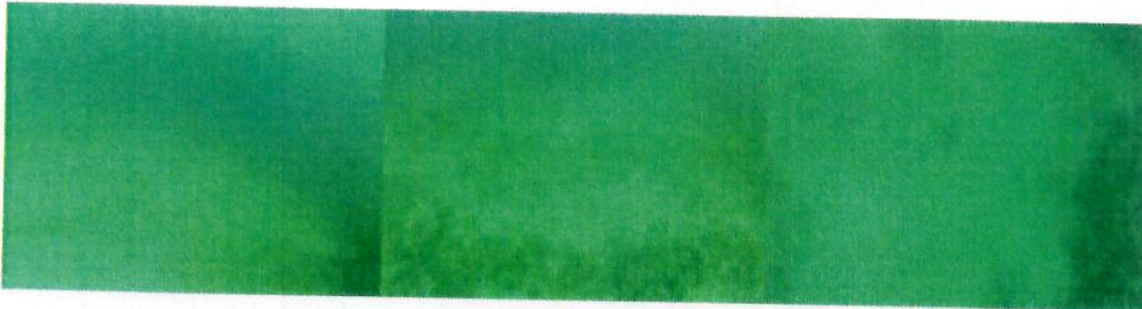
There are large scars that are the result of moorings. These are the result of mooring ropes dragging on the bottom. Some of the areas are recolonizing with algae and *H. stipulacea*.

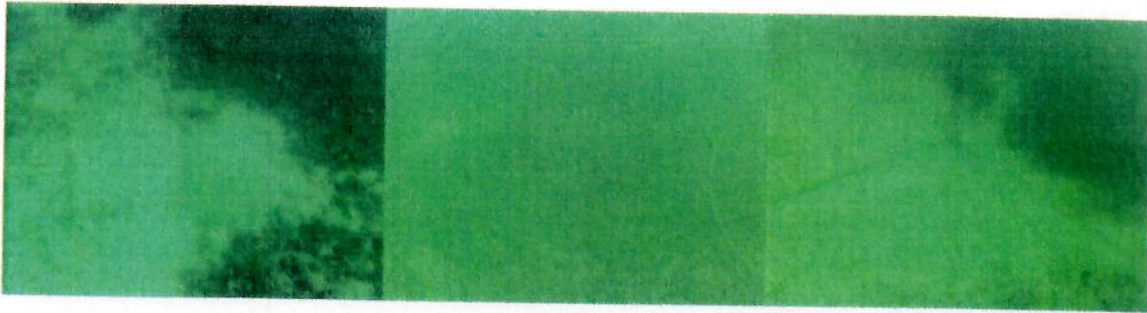
Some moorings use large rocks, other have three-point moorings which are resulting in large scour areas.

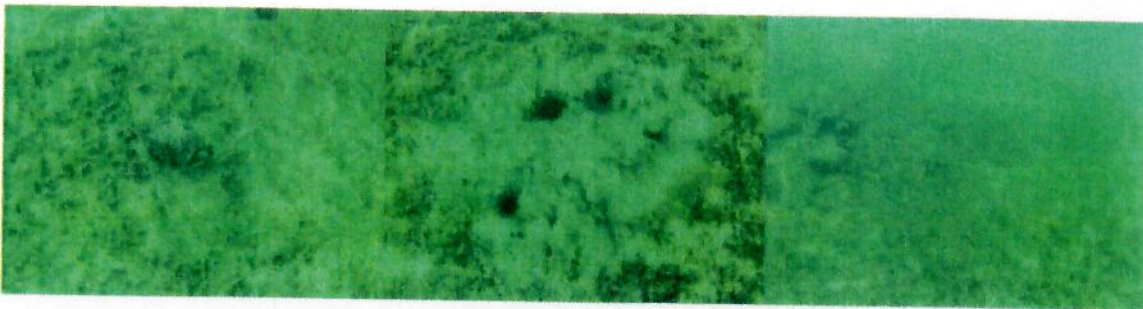
Moving to the east the area becomes intermixed with rocks and cobbles, slowly becoming a mix of emergent pavement with sand channels. At the edge of the pavement there are loose rocks which have scattered corals. As shown in the photograph there are scattered helix anchors which are scattered where they have pulled out of the shallow sand.

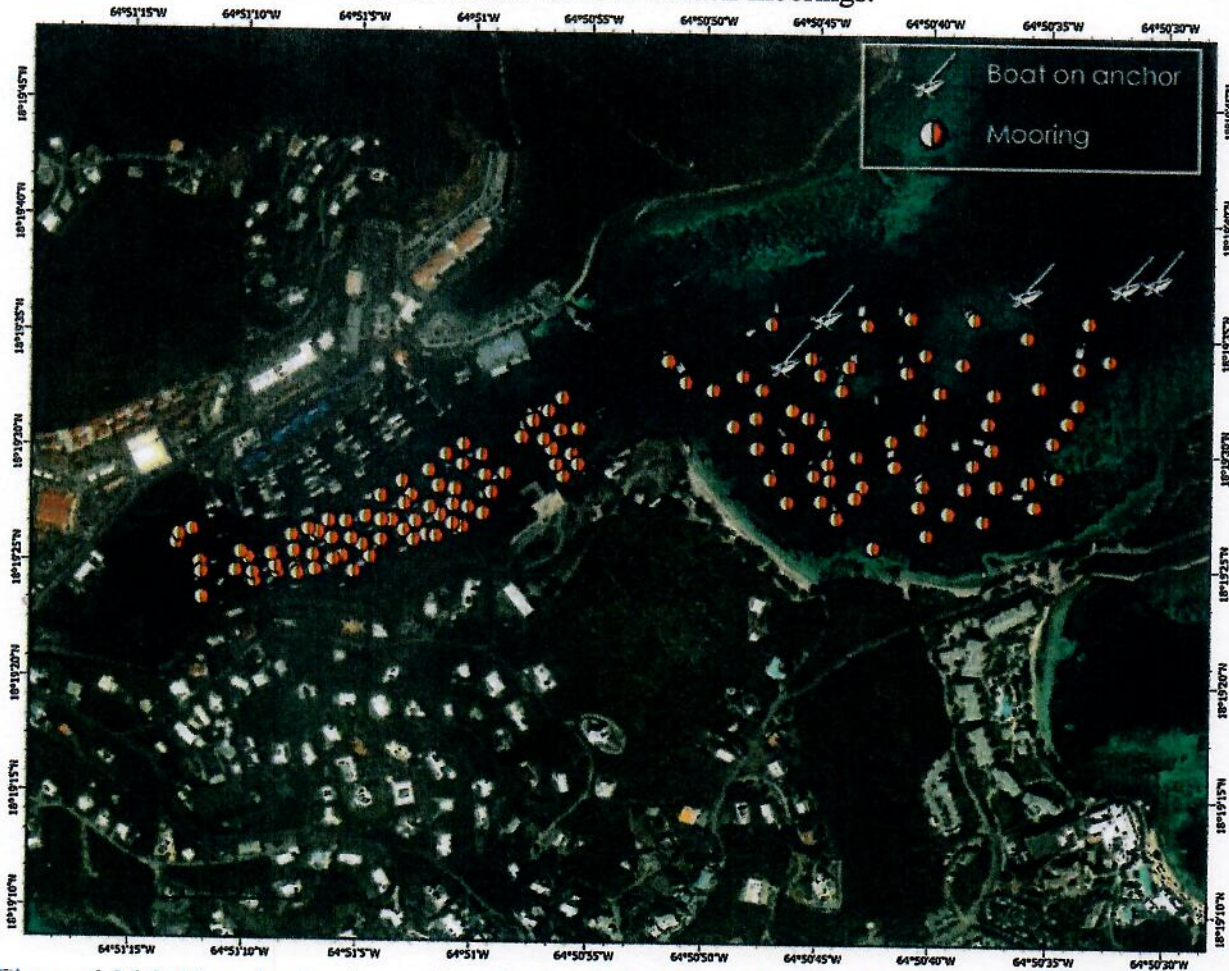
Figure 6.06.3 Vessels mooring and anchoring as of December 5, 2022.

Vessels are currently moored haphazardly in Vessup Bay. Many have anchoring systems which are damaging the seafloor. A few of the vessels are live-a-boards who simply dump their waste straight into the sea. Some vessels have been allowed to sink on their moorings.

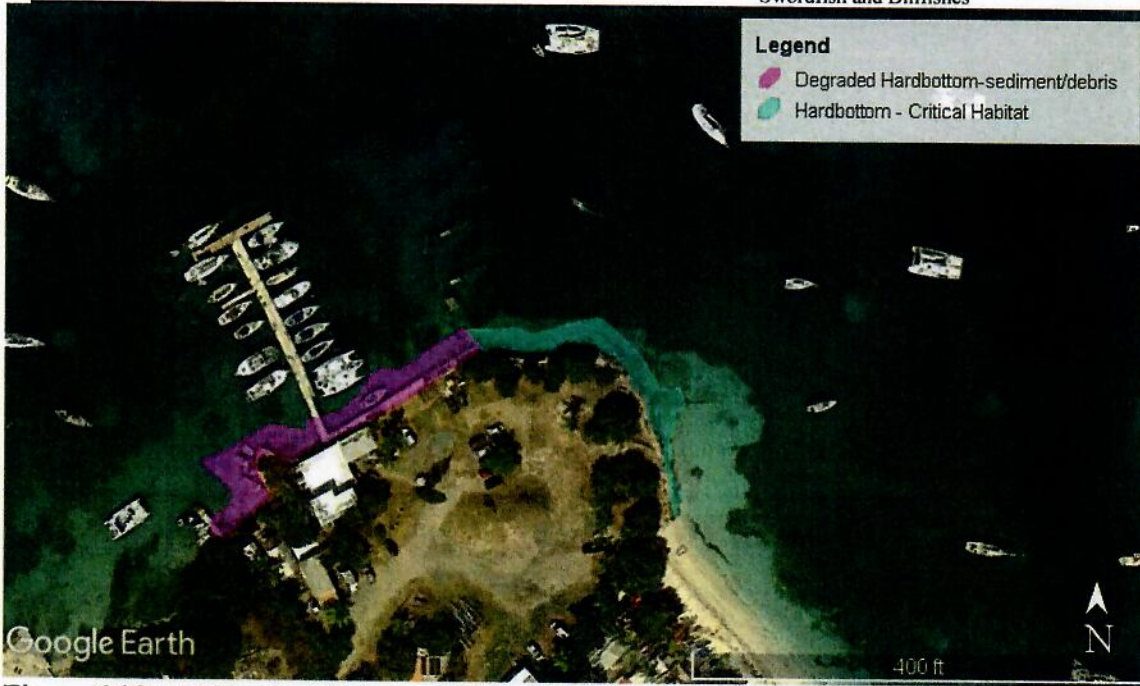
Figure 6.09.1 Critical habitat near the marina.

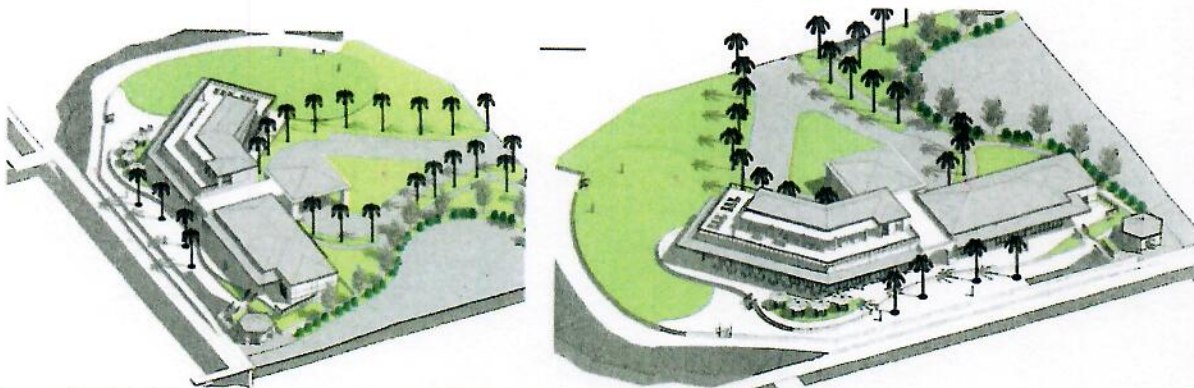
Figure 7.02.1 The Restaurant and Marina Services Building

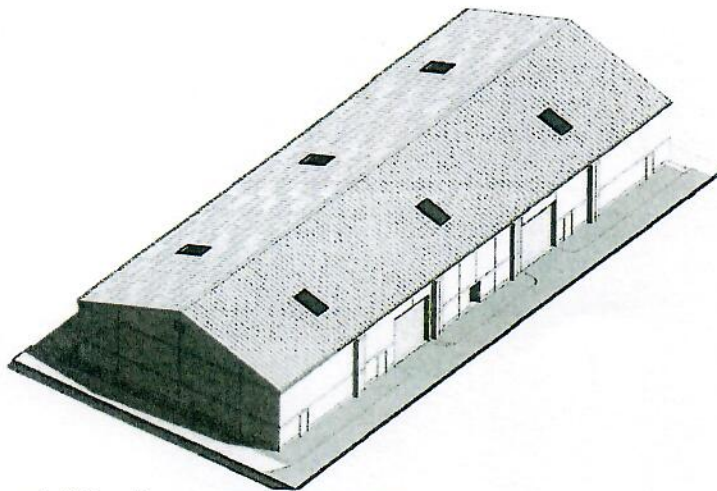
Figure 7.02.2 Axonometric Warehouse Building View

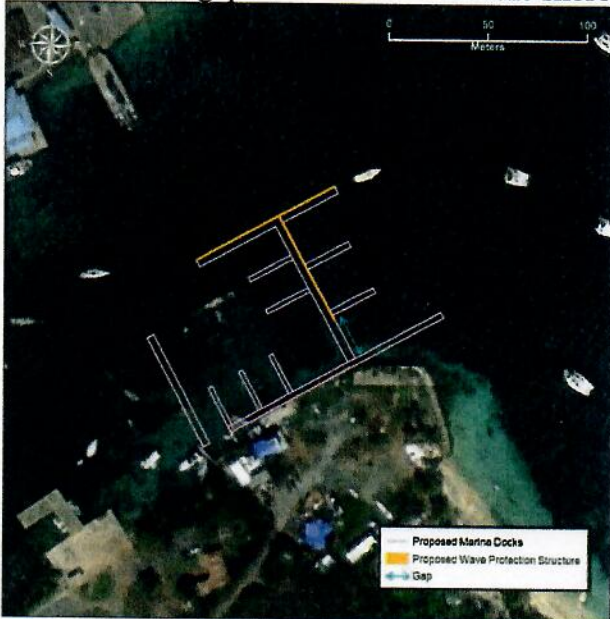
Figure 9.00.1: Proposed Marina Location and Wave Protection Structure (Design Condition)
 Initially, the design looked to extend the wave barrier perpendicular to the shoreline up to the shoreline in order to provide the maximum protection (Alternative 1). Initial flushing simulation results showed that this would significantly increase the overall flushing times within Vessup Bay. Two other alternatives were run. The first had a gap of 23 feet between the shoreline and the wave protection structure (Alternative 2). The second had a gap of 46 feet (Alternative 3). The runs with a gap of 70 feet was shown to have no negative impact on circulation.

Design condition - gap of 70 feet between the shoreline and the wave protection structure
 Alternative 1 – wave panels connecting to the shoreline
 Alternative 2 – gap of 23 feet between the shoreline and the wave protection structure
 Alternative 3 - gap of 46 feet between the shoreline and the wave protection structure
