**MAJOR LAND AND WATER
SUPPLEMENTAL ENVIRONMENTAL ASSESSMENT
IN RESPONSE TO QUESTIONS FROM PUBLIC AND CZM
FOR THE
LATITUDE 18 VESSUP BAY MARINA
ST. THOMAS, U.S. VIRGIN ISLANDS**

APPLIED TECHNOLOGY & MANAGEMENT, INC
BIOIMPACT, INC.
DESIGN DISTRICT ARCHITECTS
HARRIS CIVIL ENGINEERS, LLC
JAREDIAN DESIGN GROUP
VESSUP OPERATIONS, LLC

DECEMBER 2022

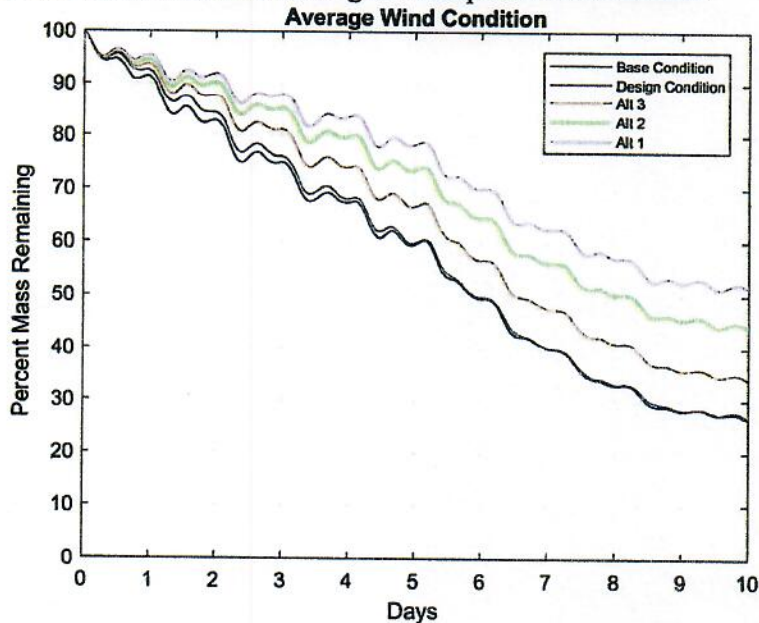
Figure 9.002: Comparison of the Percent Mass Remaining for the Alternatives, the Design Condition and the Baseline Condition under Average Wind Conditions

From the point of view of flushing Vessup Bay, the project achieved no negative impact by locating wave panels in a way that do not obstruct circulation, as demonstrated by the results of a calibrated flushing model.
